Lines/Patterns/Flaws in X-Ray Imaging Techniques

How to recognize and correct them

Technique and
Image Quality Standards

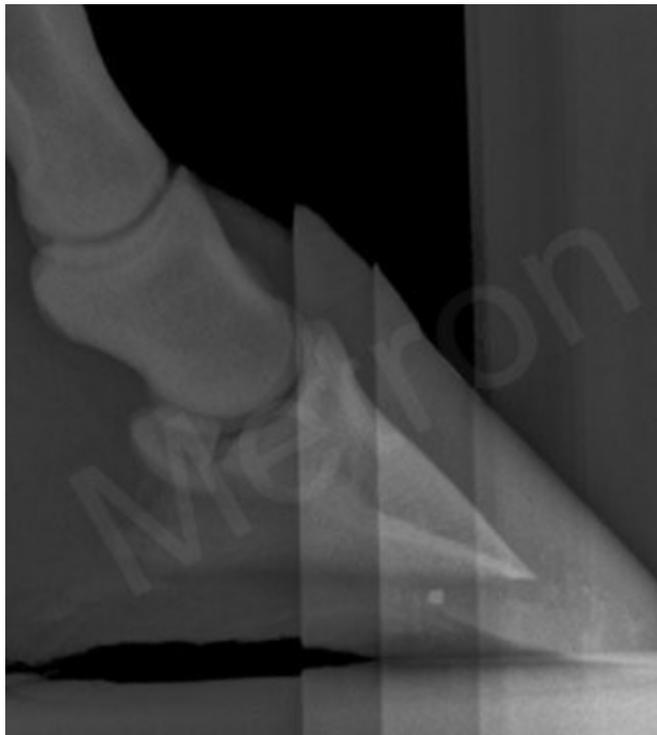
Plate feeding marks - horizontal lines 2-10cm thick caused by a plate feeding problem. If the plate sticks or jerks while feeding through the scanner, the image displays a different shade of grey in that exact image geometry. If the plate is viewed more slowly or more quickly by the scanner, the result is a change in the displayed grey scale. If this happens often, your scanner needs service.

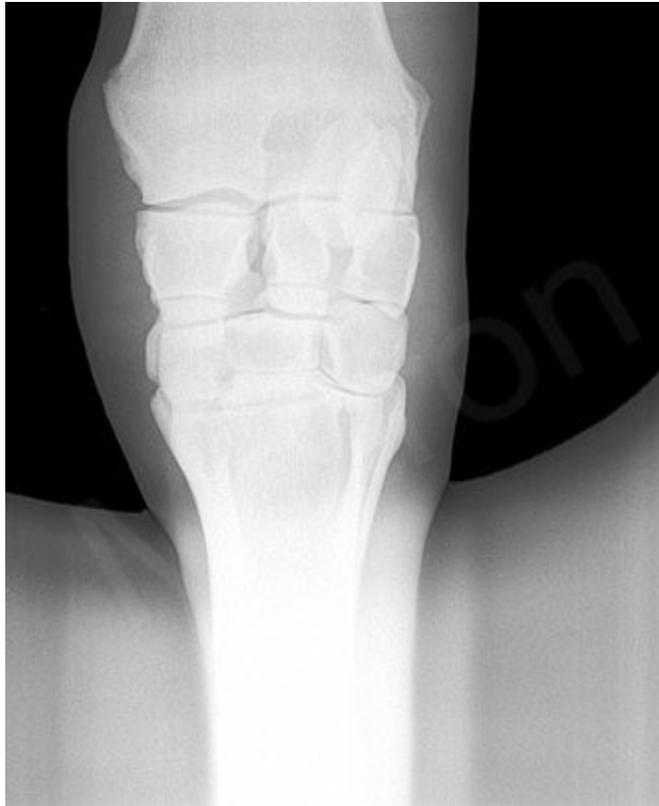
Uneven shade marks - if the plate is exposed to the light the image may show odd exposure marks like very light grey oval marks on the end of the plate. If you see odd exposure marks, are they in every image you produce or just occasionally? If not in every image, then it is likely erroneous light exposure to your CR plate.

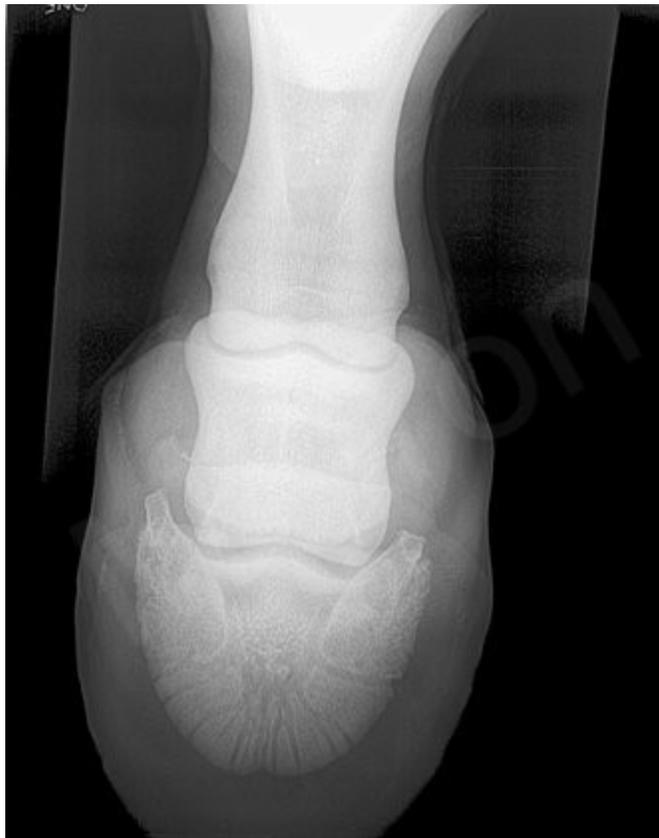
The heel effect - the outer edges of the plate appear less exposed than the center - reminding us of the Inverse Square law, the outer edge of the plate is further away from the x-ray generator than the center. Also some x-ray generators will throw more energy to the right or left of center than its opposite. In most cases, this is not a big deal because the object of interest is mostly in the middle of the image.

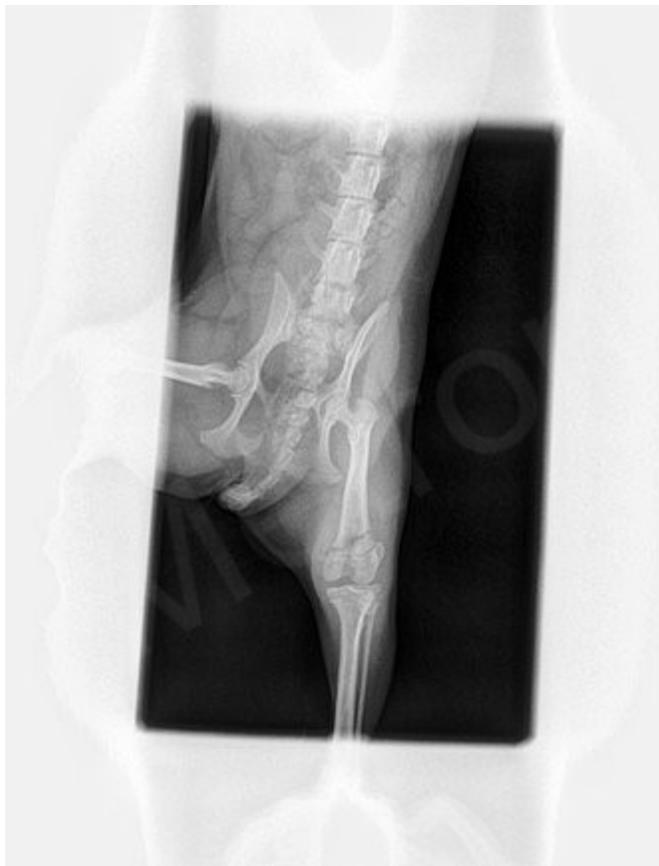
Collimation - though done on purpose, collimation can cause unexpected results. Imaging software can misinterpret the white space and inaccurately adjust to whole image causing diagnostic distortion.

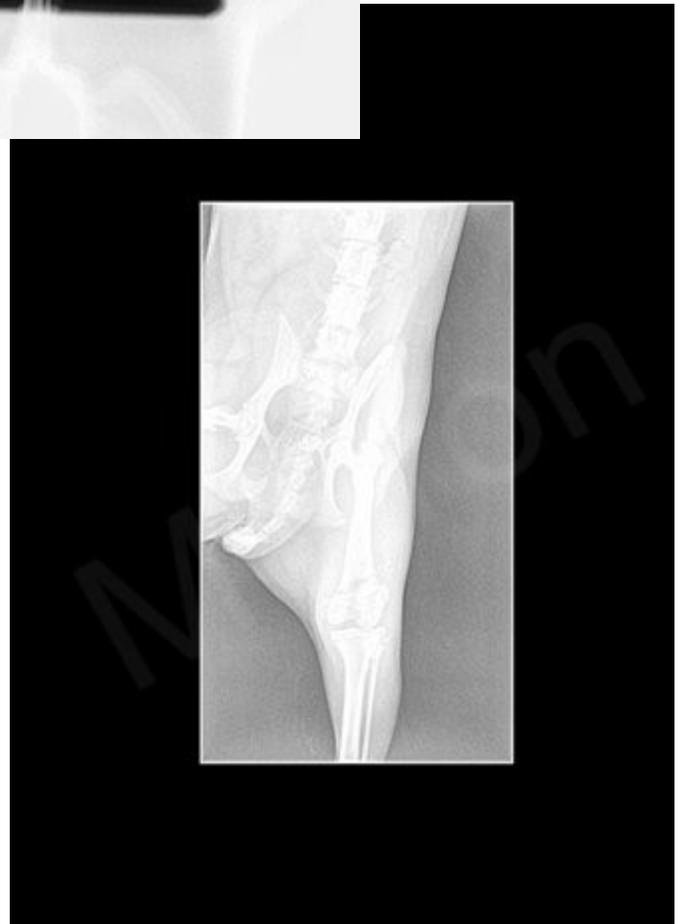
This second collimation file shows what can happen to an image after cropping or masking an image that has a lot of collimation in the original.

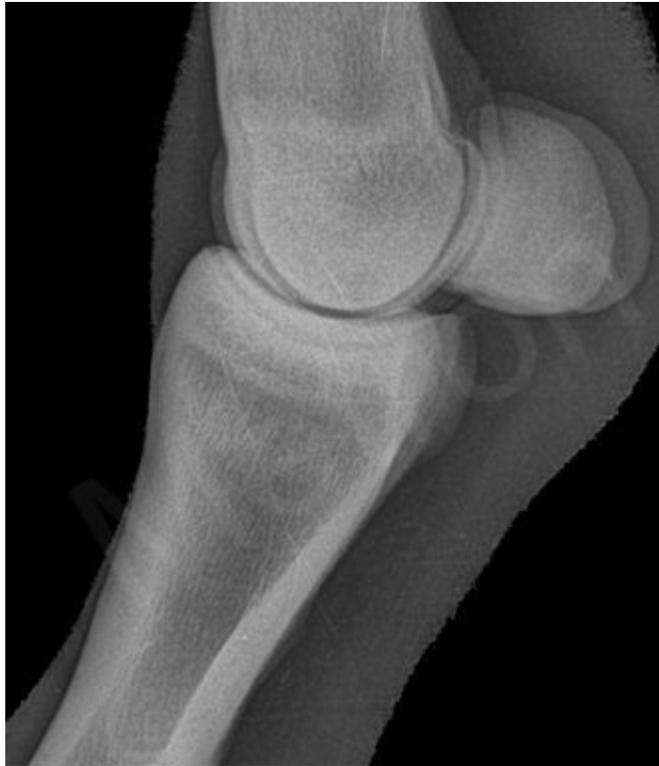
Thin white lines (not straight) - CR plates will wear out. One visible sign of CR plate wear can be the scratch marks that develop on the outside of the plate. The scratch marks can produce an exact duplicate "white" flaw mark in the digital image.

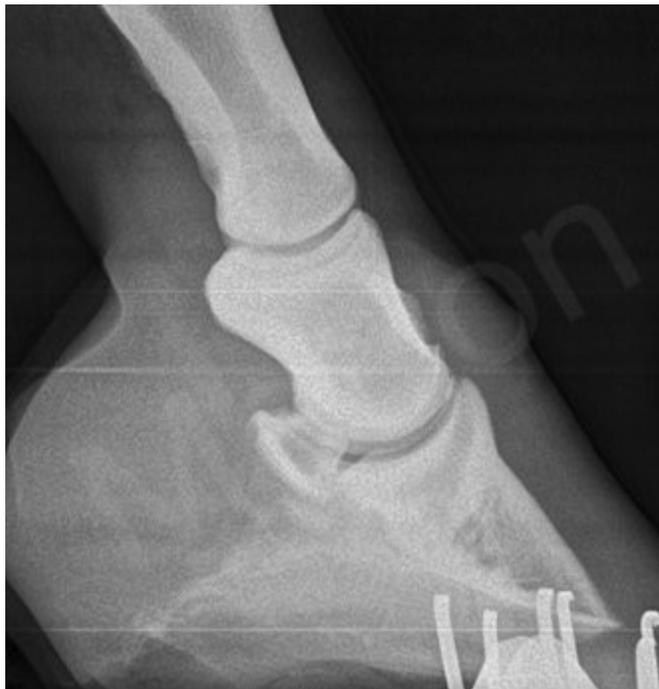
Thin white lines (straight) - hair and dust that gets caught in the optical scanner will cause white lines. This is very common and also easily resolved by using cleaning sheets on a regular basis.

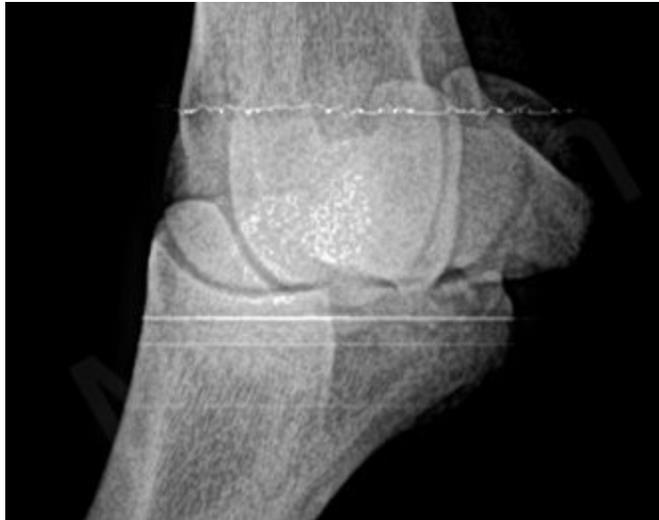
More Thin White Lines

– In this image, we have both simple hair lines and a wiggling line caused by a piece of hair that was moving as the plate passed through the scanner.

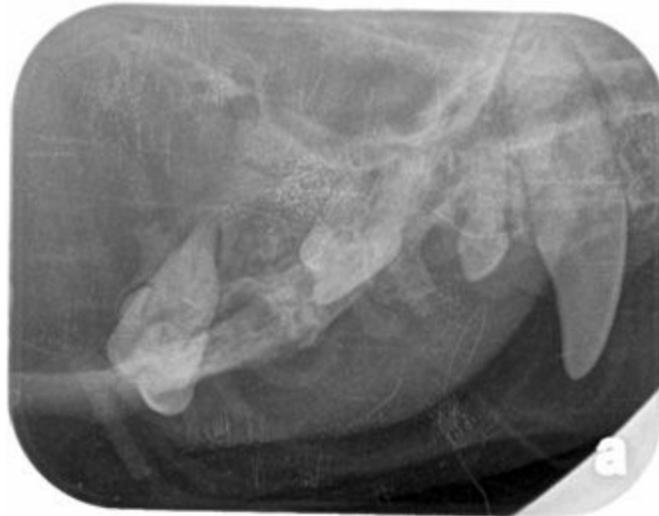
CR Plate Scratches –

this dental image contains scratch marks. The marks come from scratch marks on the surface of the plate. Some CR plates have delicate surfaces that can be easily scratched. Some CR plates can be repaired – which is cheaper than plate replacement.
